Fatalgram

U.S. Department of Labor
Mine Safety and Health Administration
Metal and Nonmetal Mine Safety and Health

Date
June 2, 1989

A 33 YEAR OLD MECHANIC/WELDER, WITH 2 YEARS EXPERIENCE WITH THE CONTRACTOR FOR WHOM HE WAS WORKING AND 10 DAYS AT THIS MINE, WAS FATALLY INJURED WHEN HE FELL APPROXIMATELY 93 FEET FROM A WATER TOWER.

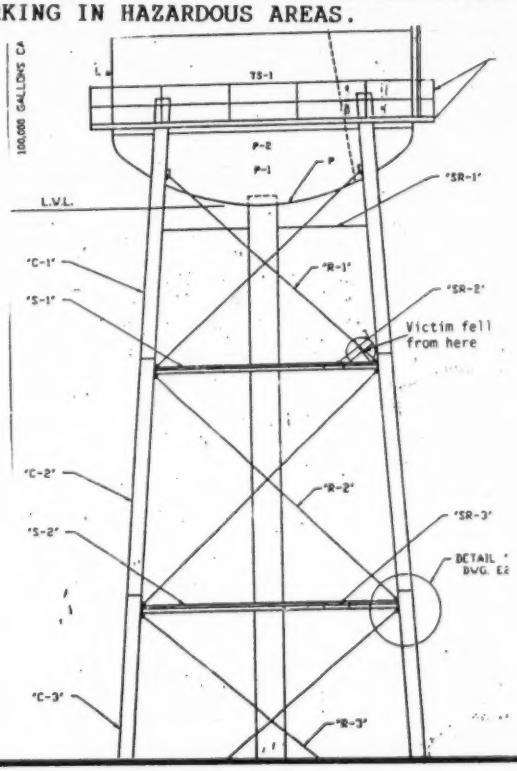
THE VICTIM WAS SITTING ON A STRUT, WELDING LEG JOINTS ON THE WATER TOWER WHICH WAS UNDER CONSTRUCTION. HE STOPPED WELDING AND AS HE WAS GETTING UP HE LOST HIS BALANCE. THE VICTIM WAS WEARING A SAFETY BELT AND LANYARD BUT IT WAS NOT ATTACHED TO THE SAFETY LINE.

EMPLOYEES MUST SECURE SAFETY LINES WHILE WORKING WHERE THERE IS A DANGER OF FALLING.

56.15005

CLOSE SUPERVISION SHOULD BE MAINTAINED AT ALL TIMES WHEN EMPLOYEES ARE WORKING IN HAZARDOUS AREAS.
